A Field Study of PCC Joint Misalignment Near Fergus Falls, Minnesota

A FIELD STUDY OF PCC JOINT MISALIGNMENT NEAR FERGUS FALLS, MINNESOTA

Final Report

May 1999

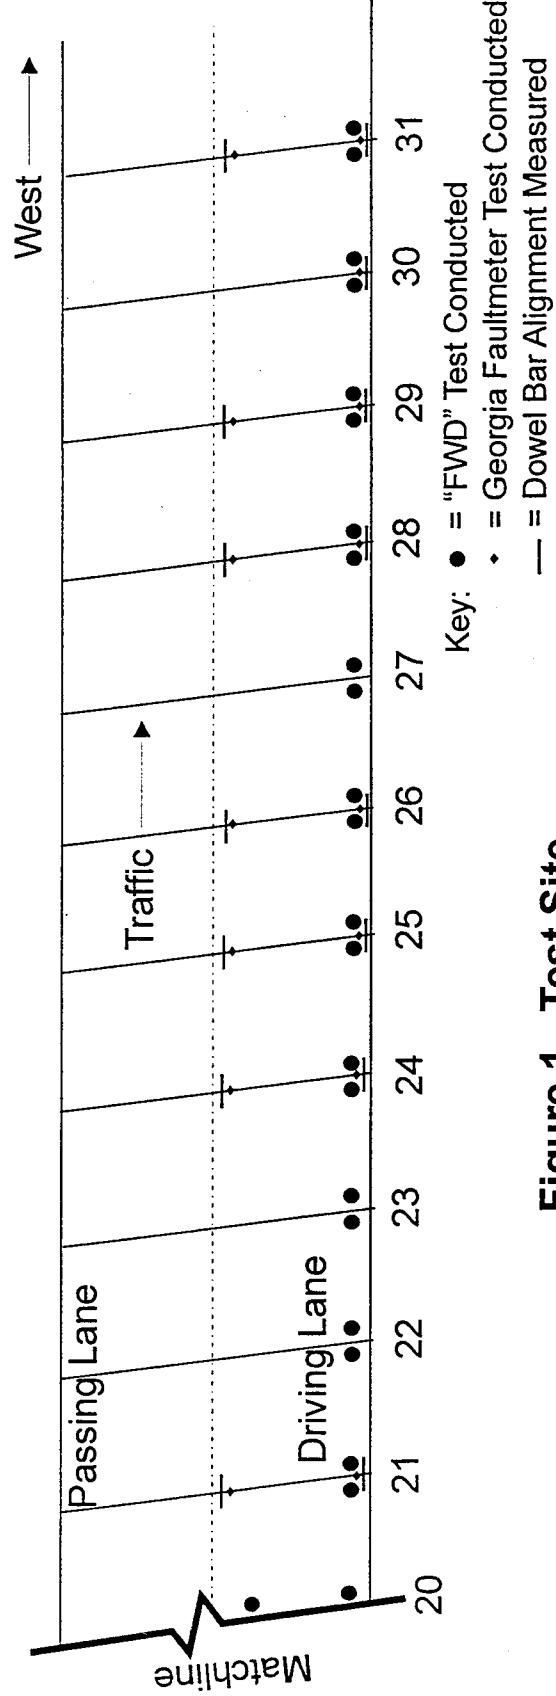
Figure 1. Test Site

Dowel bar alignment measurements were taken along fifteen selected driving lane transverse joints in the area under investigation. See Figure 1. A Proceq PROFOMETER 3 Rebar Locator was used to determine the lateral and longitudinal location of four to five of the twelve dowel bars in each joint. Dowel bars 1,2,10,11, and 12 were located; where dowel number 1 designates the dowel bar closest to the driving lane shoulder. The measurements are believed to be within ± 13 mm (± 0.5 in) of the actual location.

Faulting (vertical stepping) measurements were taken at two locations along each selected joint. See Figure 1 for locations. A Georgia type faultmeter was used to obtain the measurements. See Table 2 for results. Several of the joints have faulting in excess of 6 mm (0.25 in), with the highest reading measured at 12.8 mm (0.50 in).

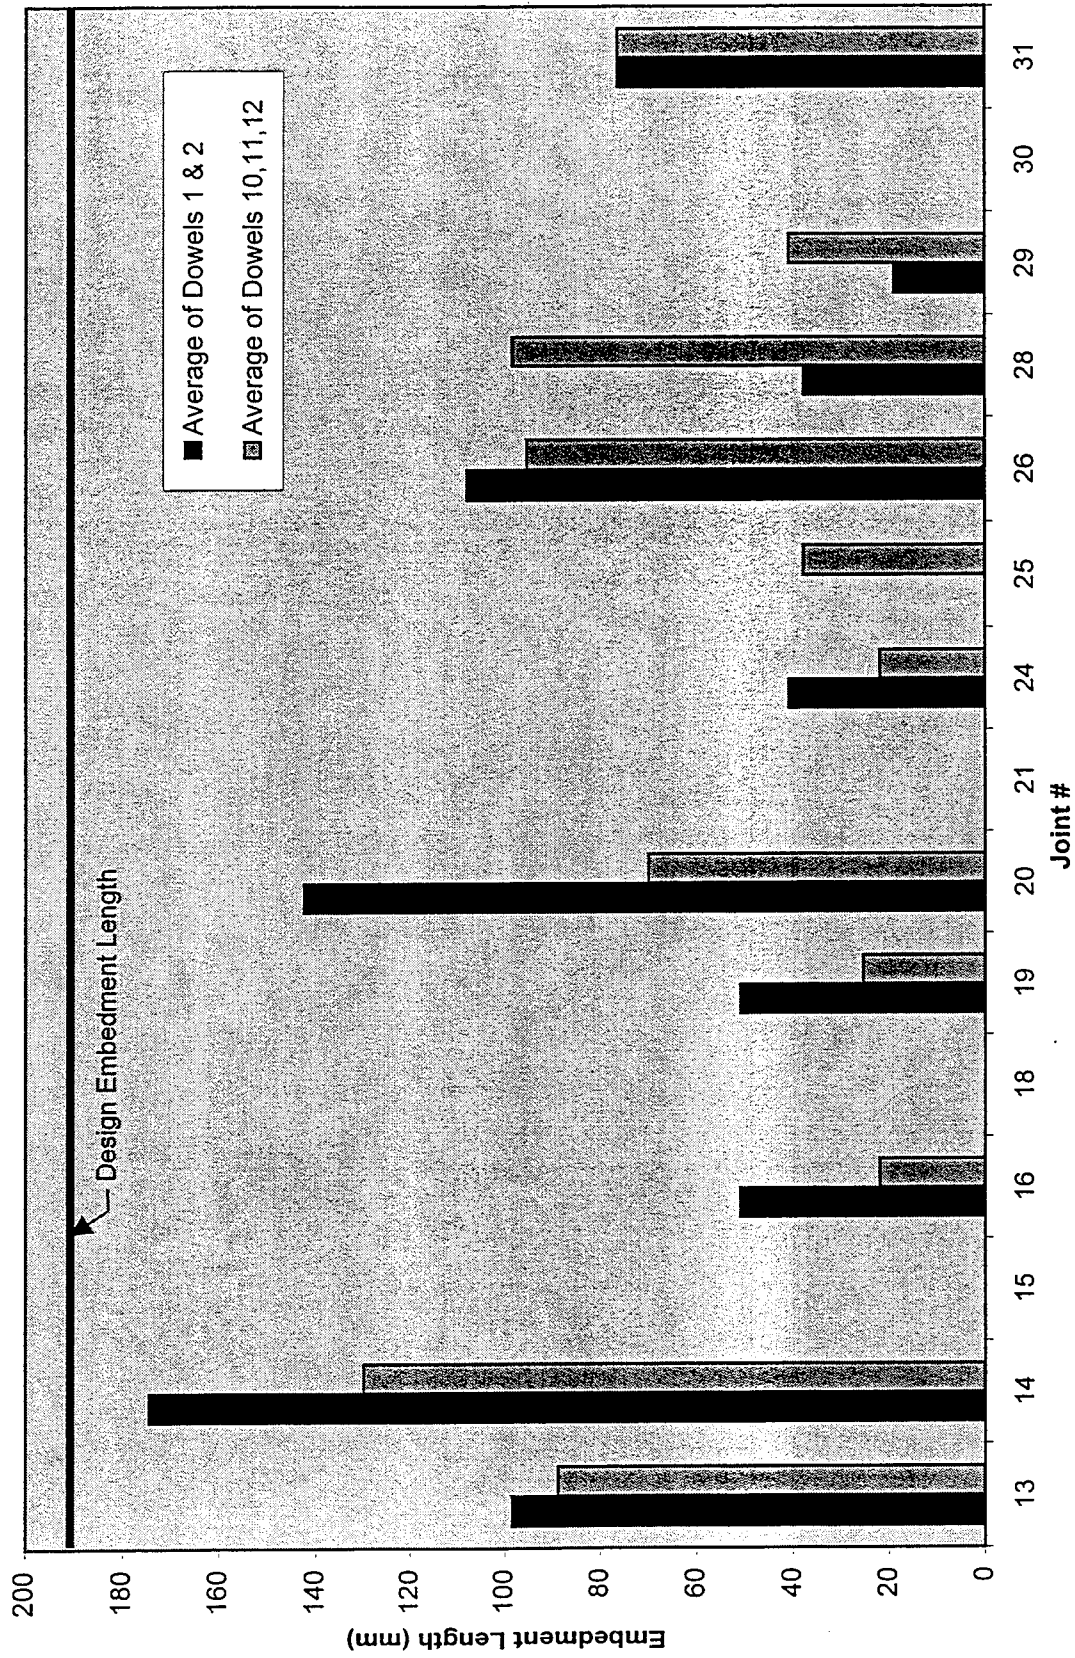
Figure 3. Dowel bar embedment lengths

Based on the longitudinal measurements, dowel bar embedment lengths were determined. Table 1 clearly shows the large variation in embedment lengths found. Positive embedment values correlate to lengths on the approach panel side (see Figure 2). Figure 3 shows embedment lengths graphically. Note that embedment lengths greater than 356 mm (14 in) or less than zero are shown as zero on this graph.

Ten of the selected joints were found to have dowel embedment lengths less than or equal to 51 mm (2 in). Of those ten, five had no dowels spanning the joint. See Appendix A for copies of the field data collection sheets.

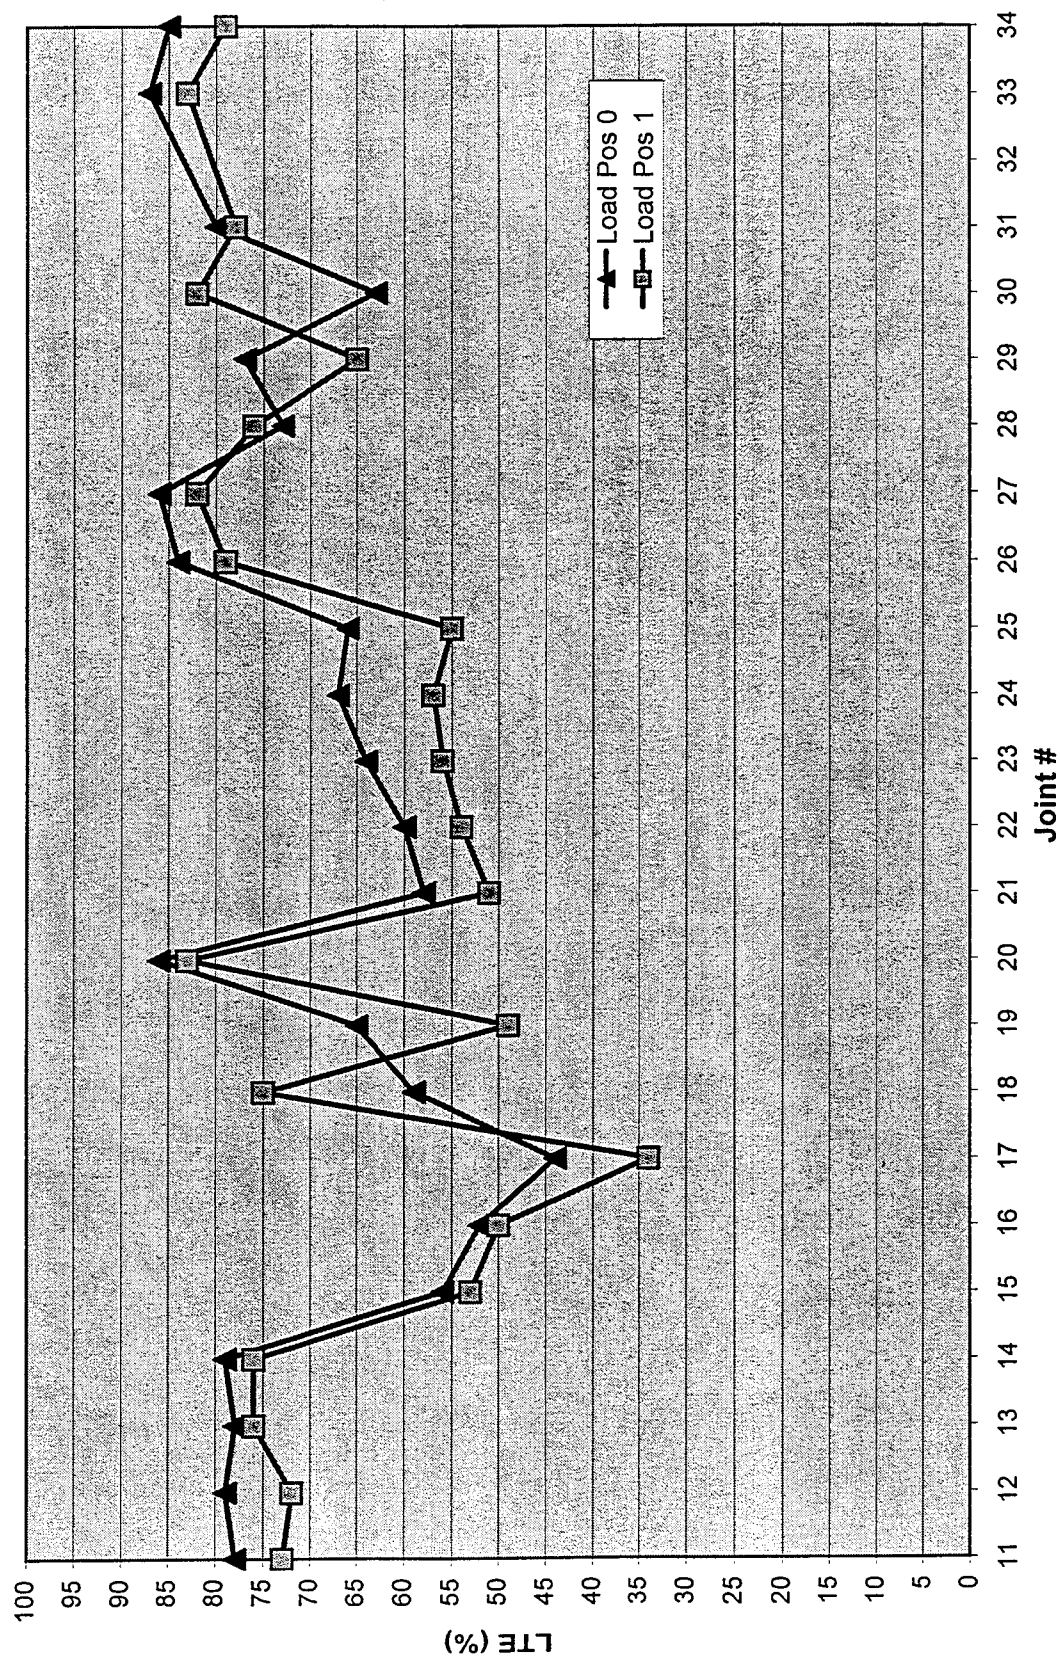
Figure 5a. Load Transfer Efficiency - Near Dowel #1

The LTE values found ranged from 30 to 87%. Figures 5a and 5b show LTE versus joint number for dowel locations #1 and #12 respectively.

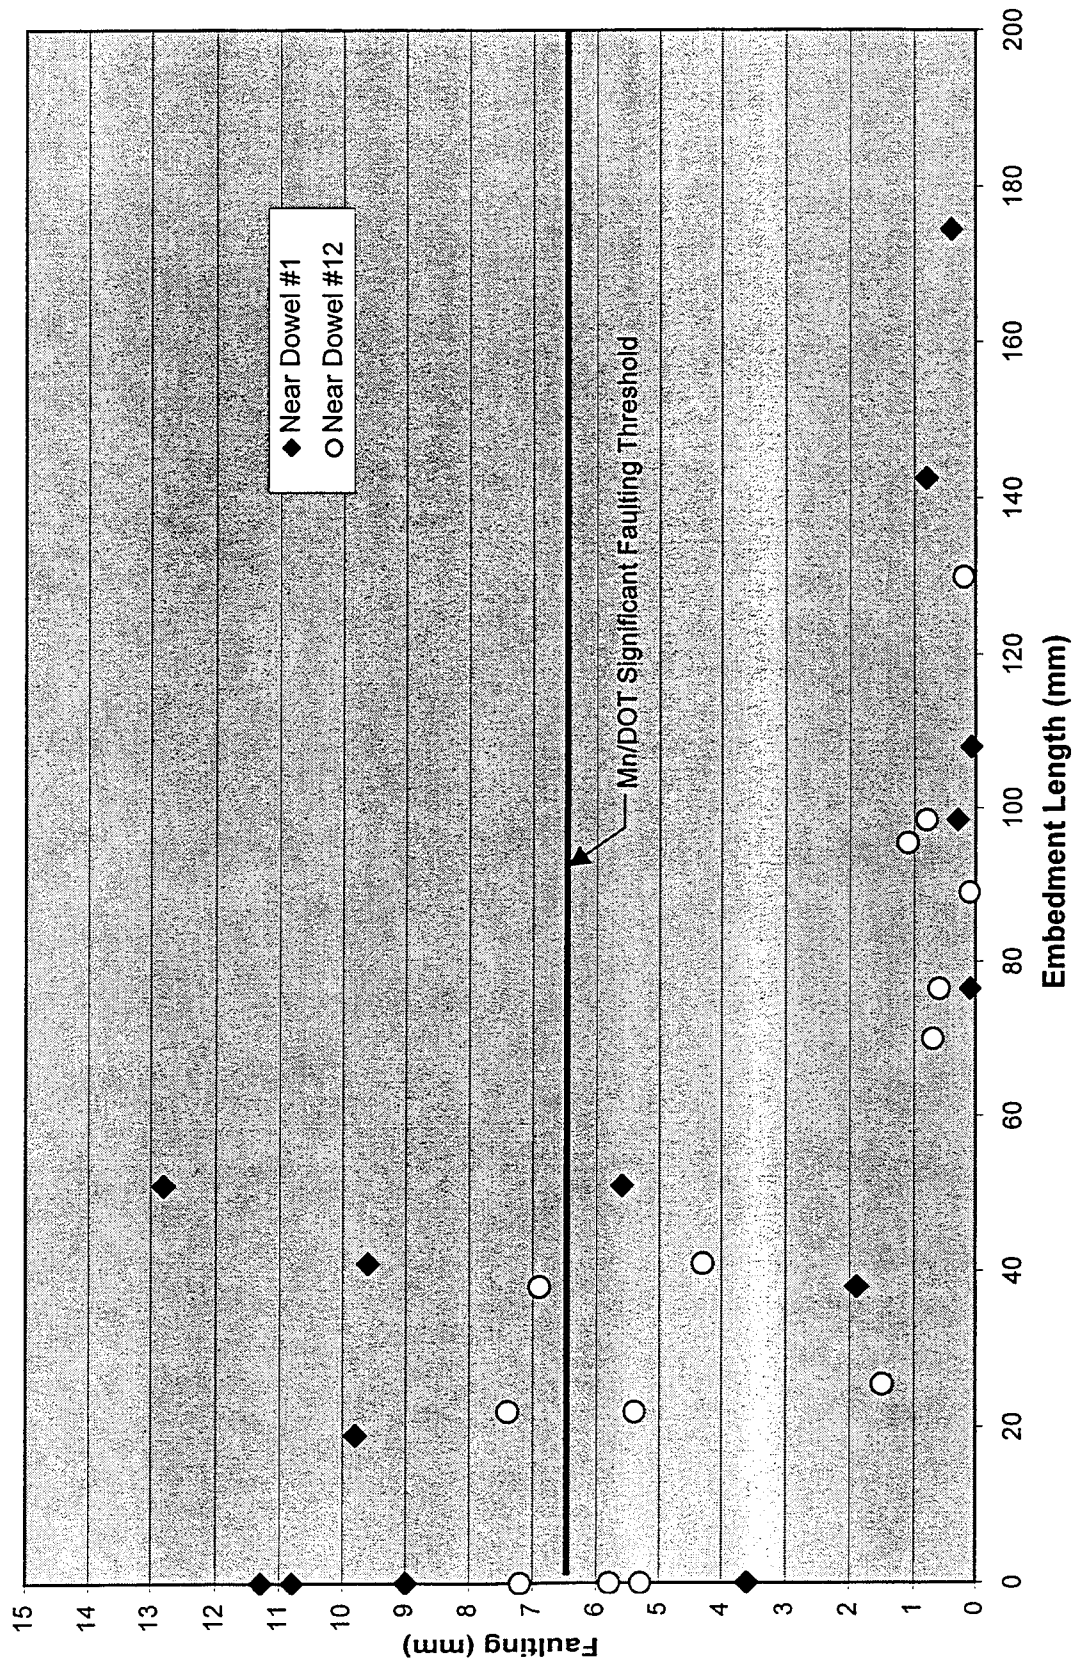
Figure 6. Embedment Length versus Joint Faulting

Figure 6 shows a comparison of dowel bar embedment length versus faulting for the selected joints. From the graph, it appears in this case that significant early faulting occurs when embedment lengths are less than 64 mm (2.5 in). The Minnesota Department of Transportation (Mn/DOT) considers faulting to be significant if it is greater than 6.4 mm (0.25 in) [2].

One must be careful not to immediately conclude that the minimum embedment length required is only 64 mm (2.5 in). Not only must there be tolerances for proper location of the dowels relative to the joint (during construction), but the results presented here are for a 12 year

old pavement (relatively new). State-of-the-art design guides recommend an embedment length of 6 times the diameter of the dowel [190 mm (7.5 in) for this case] for adequate contribution to long term load transfer [3].

No significant difference in faulting behavior was observed between dowel #1 (near shoulder) and dowel #12 (near centerline) locations.

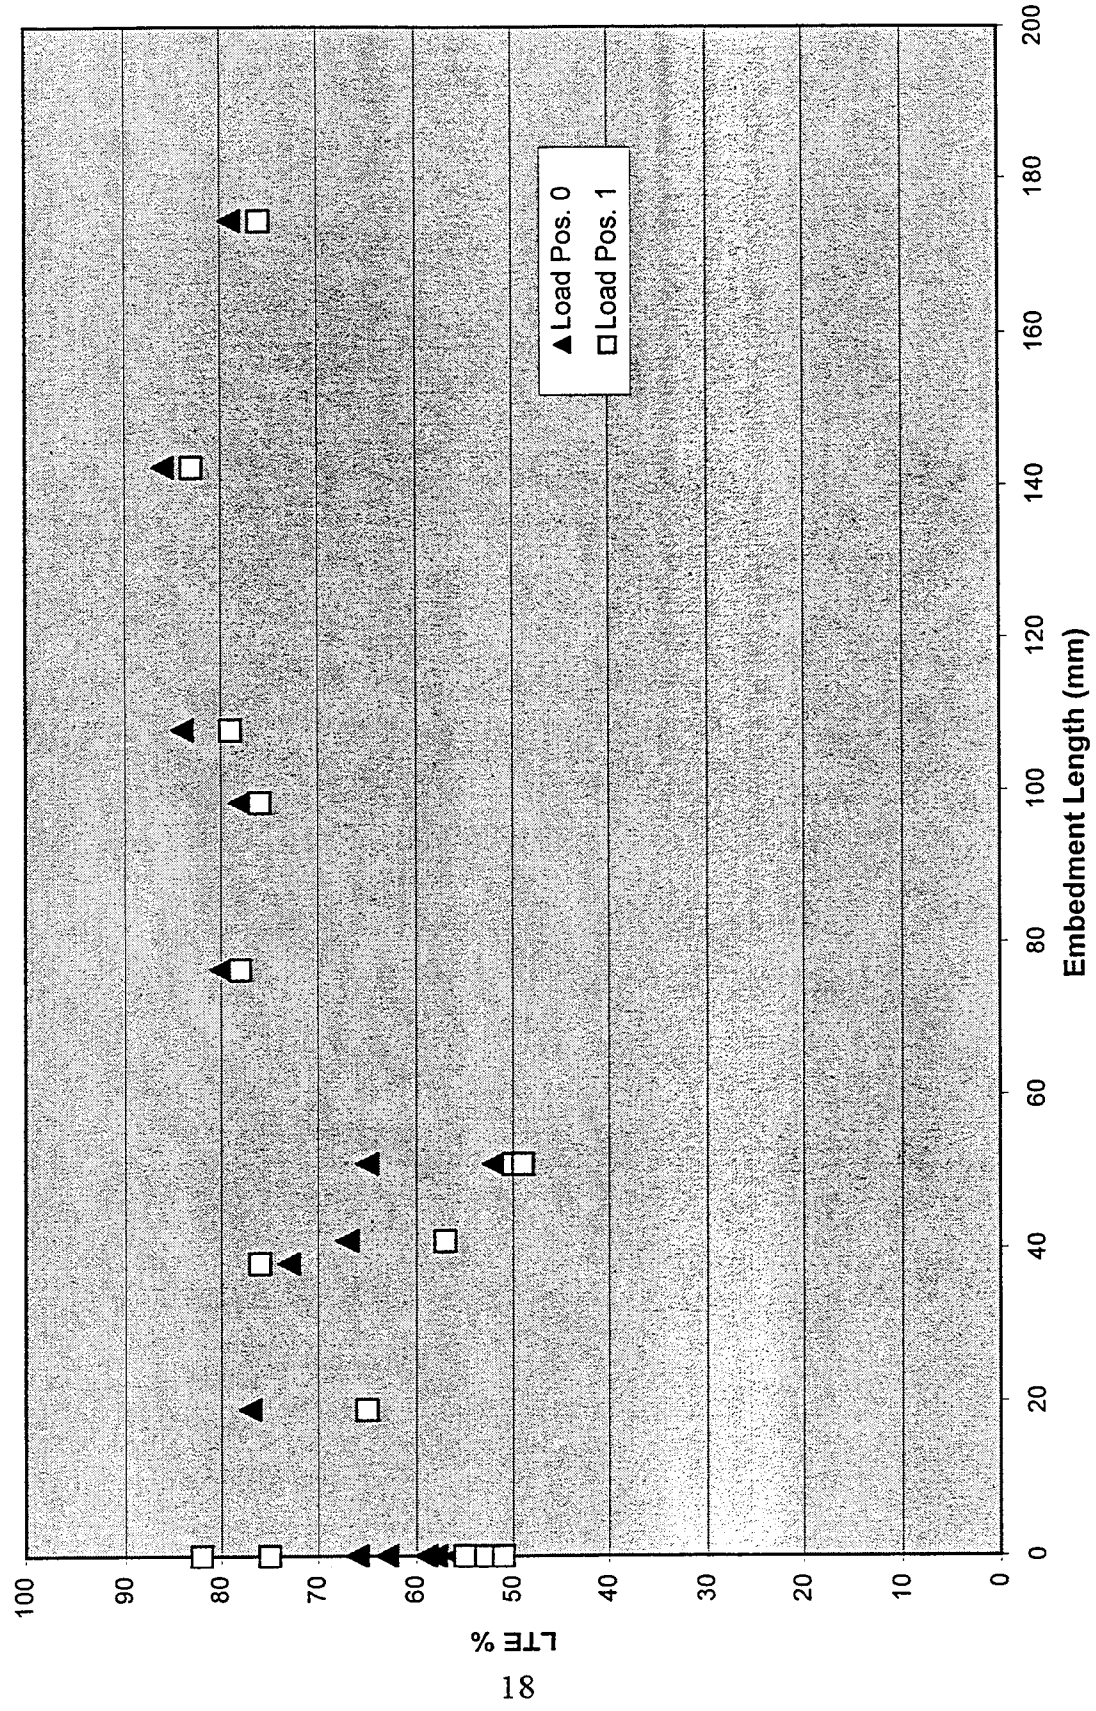
Figure 7a. Embedment length vs load transfer efficiency - Near Dowel #1

Table 4, and Figures 7a and 7b, show a comparison of embedment length and load transfer efficiency (LTE) for the selected joints. As observed in Figure 6, it appears an embedment length less than 64 mm (2.5 in) results in significantly lower (and more variable) LTE values. As in the previous comparison, caution must be taken in that this is only a 12 year old pavement. More importantly, LTE values can be strongly affected by the temperature and moisture gradients present at the time of FWD testing. Due to the lack of any instrumentation to measure these effects (other than surface and air temperatures obtained by the FWD machine), the values presented were not adjusted accordingly.

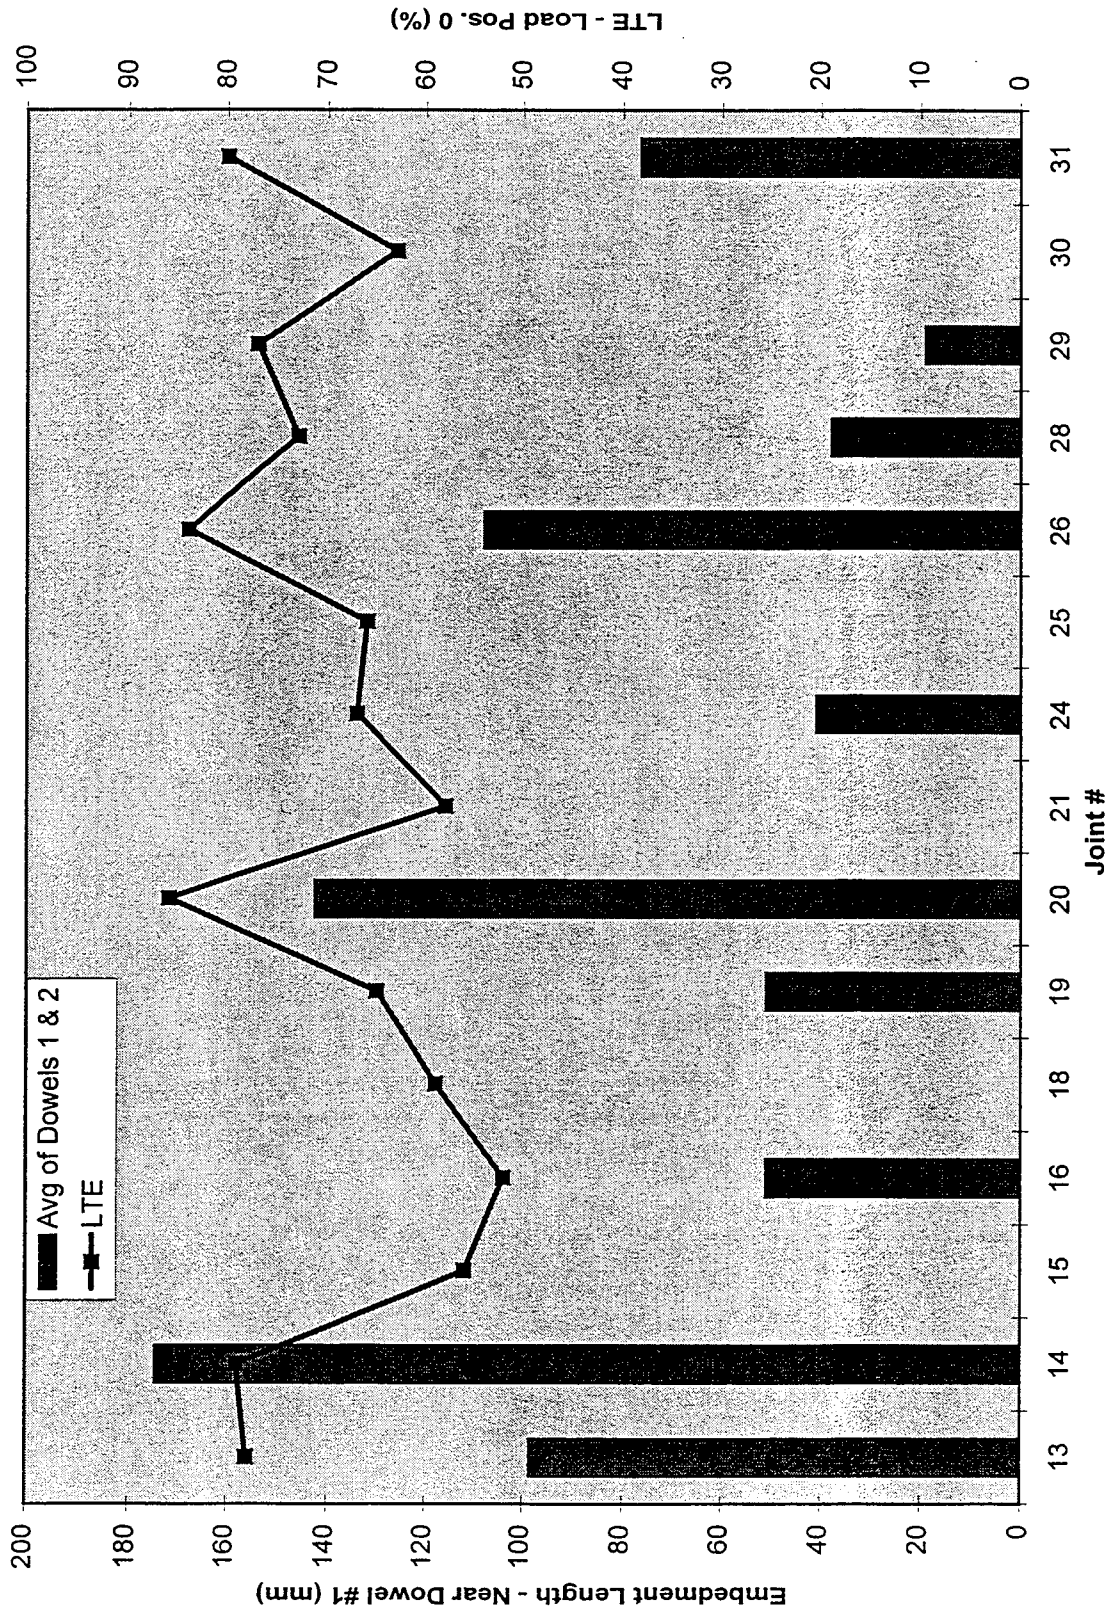
Figure 8a. Variation of embedment length and LTE
for load position 0

Figures 8a thru 8d demonstrate how the embedment length and LTE at each load position varies for each joint under investigation. Qualitatively, the behavior is as expected, with higher embedment lengths resulting in higher LTE values. LTE values for the leave side of the slabs (load positions 1 and 3) show more variability than the corresponding approach side.

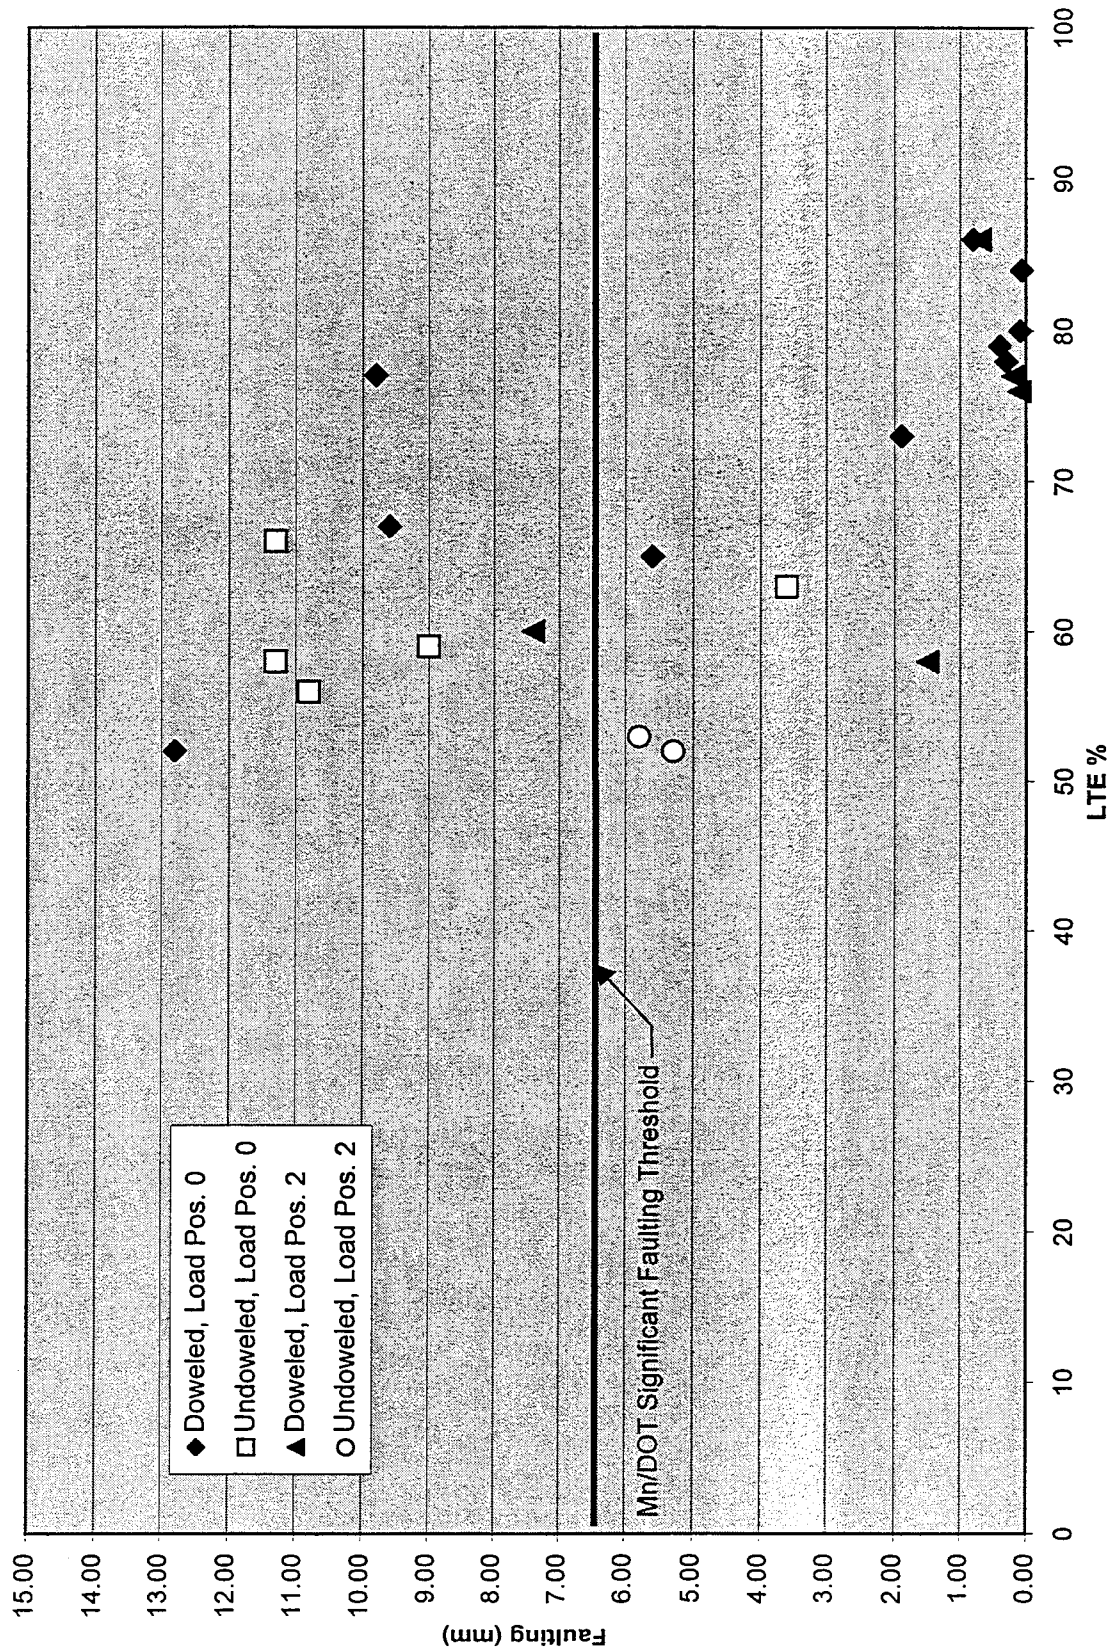
Figure 9a. LTE versus joint faulting - Approach panel side

Figures 9a and 9b show a comparison of LTE and faulting for the selected joints. As might be expected, declines in LTE result in increased faulting. Note that data points from what may be considered "undoweled" joints [less than 25 mm (1 in) embedment length] all exhibit significant faulting after only 12 years of traffic.

Since several of the joints investigated can be considered undoweled, the heavy truck traffic on this pavement will accelerate the faulting of these joints. To slow the degradation of the joints, one recommendation might be the installation of retrofit dowel bars. This could restore a good portion of the load transfer efficiency necessary for long term joint performance. The length of this distressed area makes it highly suitable as a test section for evaluating the effectiveness of retrofit dowel bars.
